DEPARTMENT OF TRANSPORTATION**DIVISION OF ENGINEERING SERVICES**

Quality Assurance and Source Inspection

Contract #: 04-0120F4Cty: SF/ALA Rte: 80 PM: 13.2/13.9File #: 69.28**WELDING INSPECTION REPORT****Resident Engineer:**Pursell, Gary**Address:** 333 Burma Road**City:** Oakland, CA 94607**Report No:** WIR-001121**Date Inspected:** 19-Dec-2007**Project Name:** SAS Superstructure**OSM Arrival Time:** 1400**Prime Contractor:** American Bridge/Fluor Enterprises, a JV**OSM Departure Time:** 2330**Contractor:** Zhenhua Port Machinery Company, Ltd (ZPMC), Changxing Island **Location:** Shanghai, China**CWI Name:** Lay Tau and Zhang Jiadi**CWI Present:** Yes No**Inspected CWI report:** Yes No N/A**Rod Oven in Use:** Yes No N/A**Electrode to specification:** Yes No N/A**Weld Procedures Followed:** Yes No N/A**Qualified Welders:** Yes No N/A**Verified Joint Fit-up:** Yes No N/A**Approved Drawings:** Yes No N/A**Approved WPS:** Yes No N/A**Delayed / Cancelled:** Yes No N/A**Bridge No:** 34-0006**Component:** 77 meter mock up assembly**Summary of Items Observed:**

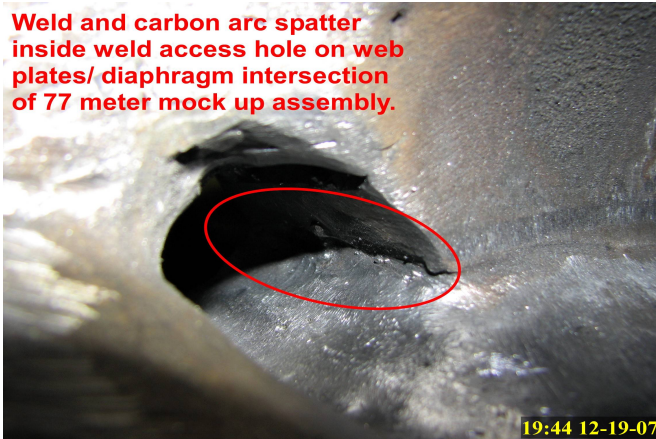
Weld and carbon arc spatter inside weld access hole on web plates/ diaphragm intersection of 77 meter mock up assembly.

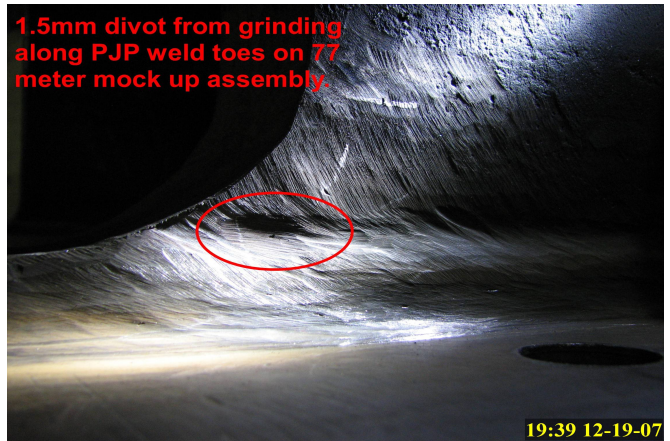
1.5mm divot from grinding along PJP weld toes on 77 meter mock up assembly

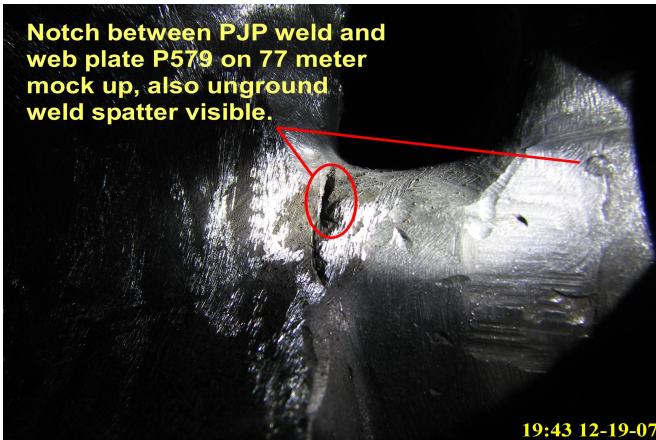
Notch between PJP weld and web plate P579 on 77 meter mock up, also unground weld spatter visible.

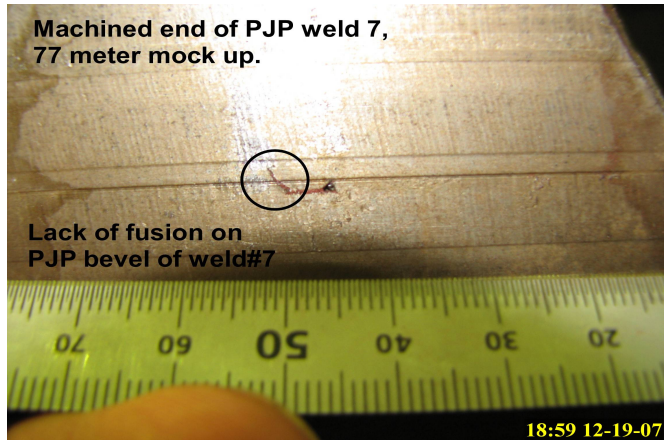
Machined end of PJP weld 7, 77 meter mock up.

Lack of fusion on PJP bevel of weld#7

Zhang Jiadi. The QC Liaisons then spoke with other ZPMC workers and the QA inspector observed ZPMC workers grinding on the end of the PJP weld that appeared to have lack of fusion. The QA inspector was informed that repairs will be done. The QA inspector asked how the repairs would be conducted and was informed that a technician will conduct MT on the PJP weld but no other information was given to the QA inspector at that time. The QA inspector was then asked by the QC Liaison if work could continue with the fabrication of the 77 meter mock up assembly. The QA inspector replied that the QA inspector has no authority to stop ZPMC from working and the apparent non-conforming conditions of the welds observed would be reported.
